MARYLAND GEOLOGICAL SURVEY Merryman Hall The Johns Hopkins University Baltimore, Maryland 21218 (301) 235-0771

COUNTIES (MD/PA)	BALTIMORE/YORK
M&D milestone no.	47 (50)
MHT-HSI no. MHT MAGI no.	BA-1566
MHT MAGI no.	
RROTECTED ENDA	NGERED/MIRRING

FIELD SHEET: MASON & DIXON LINE, MARYLAND-PENNSYLVANIA BOUNDARY MARKER SURVEY

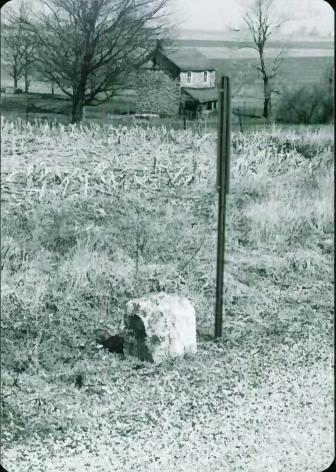
PHOTO: ALICE MARTIN 3/9/79 (1979.32)

HED WEST LINE: HILLSTONE 47 (50)
LOCKING NE

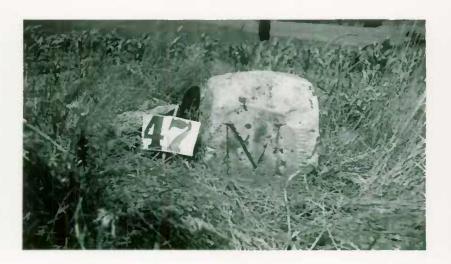
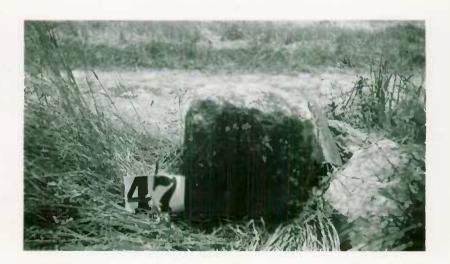
50. Original monument, being exposed to machinery, is chipped on south side. Firm foundation.

HEREN LEVEL NEST LIVE: MILESTREE 119 (SE)

PHOTE: DIE 21 TRUSPIL C. 1948-60 (ARMARIA)

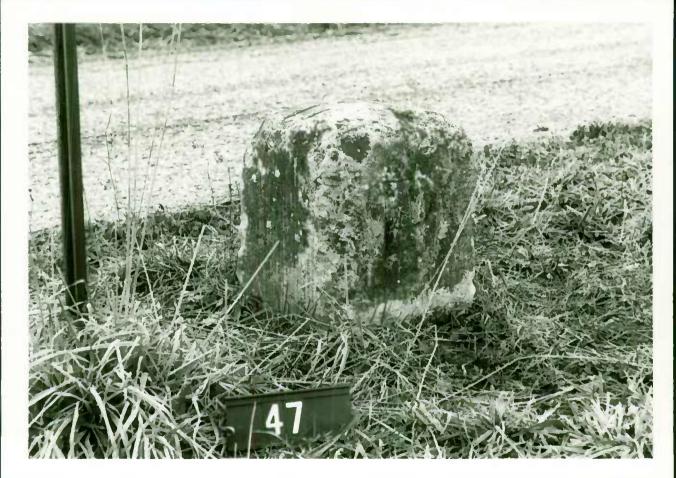
PHOTO: ALICE MARTIN 1/19/80 (1880-2.6)

1979-80 Inspection notes: order no. 47 (50); photos/negatives/slides no. 47 (50) 47 (50). Original M&D monument of 1766 in place, in fair condition, firmly set; letters clear but chips all edges, corners & south face. Endangered by site.

MUSIN 2 DIVON WEST LINE I THESTONE HT (50)

NE CORNER (-10)

I recommend MGS contact with DPW and superintendent to/reinforce concern about preservation of this stone.

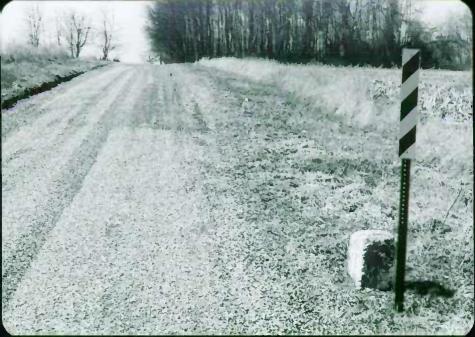
PHOTO: ALKE MARTIN 3/9/79 (1979.3.14)

MED WEST LINE: MILESTONE 47 (50)

VIEW OVE W OF STONE, READ EHAZARD

MARKER
